**SITE ASSESSMENT REPORT FOR THE
CALUMET AND HECLA POWER PLANT SITE
LAKE LINDEN, HOUGHTON COUNTY, MICHIGAN**

UNITED STATES ENVIRONMENTAL PROTECTION AGENCY

Date Prepared	December 7, 2010
Technical Direction Document No.	S05-0001-1003-030
Contract No.	EP-S5-06-04
Document Control No.	988-2A-AHLZ
WESTON START Project Manager	Daniel M. Capone
Telephone No.	517-381-5932
U.S. EPA On-Scene Coordinator	Ralph Dollhopf

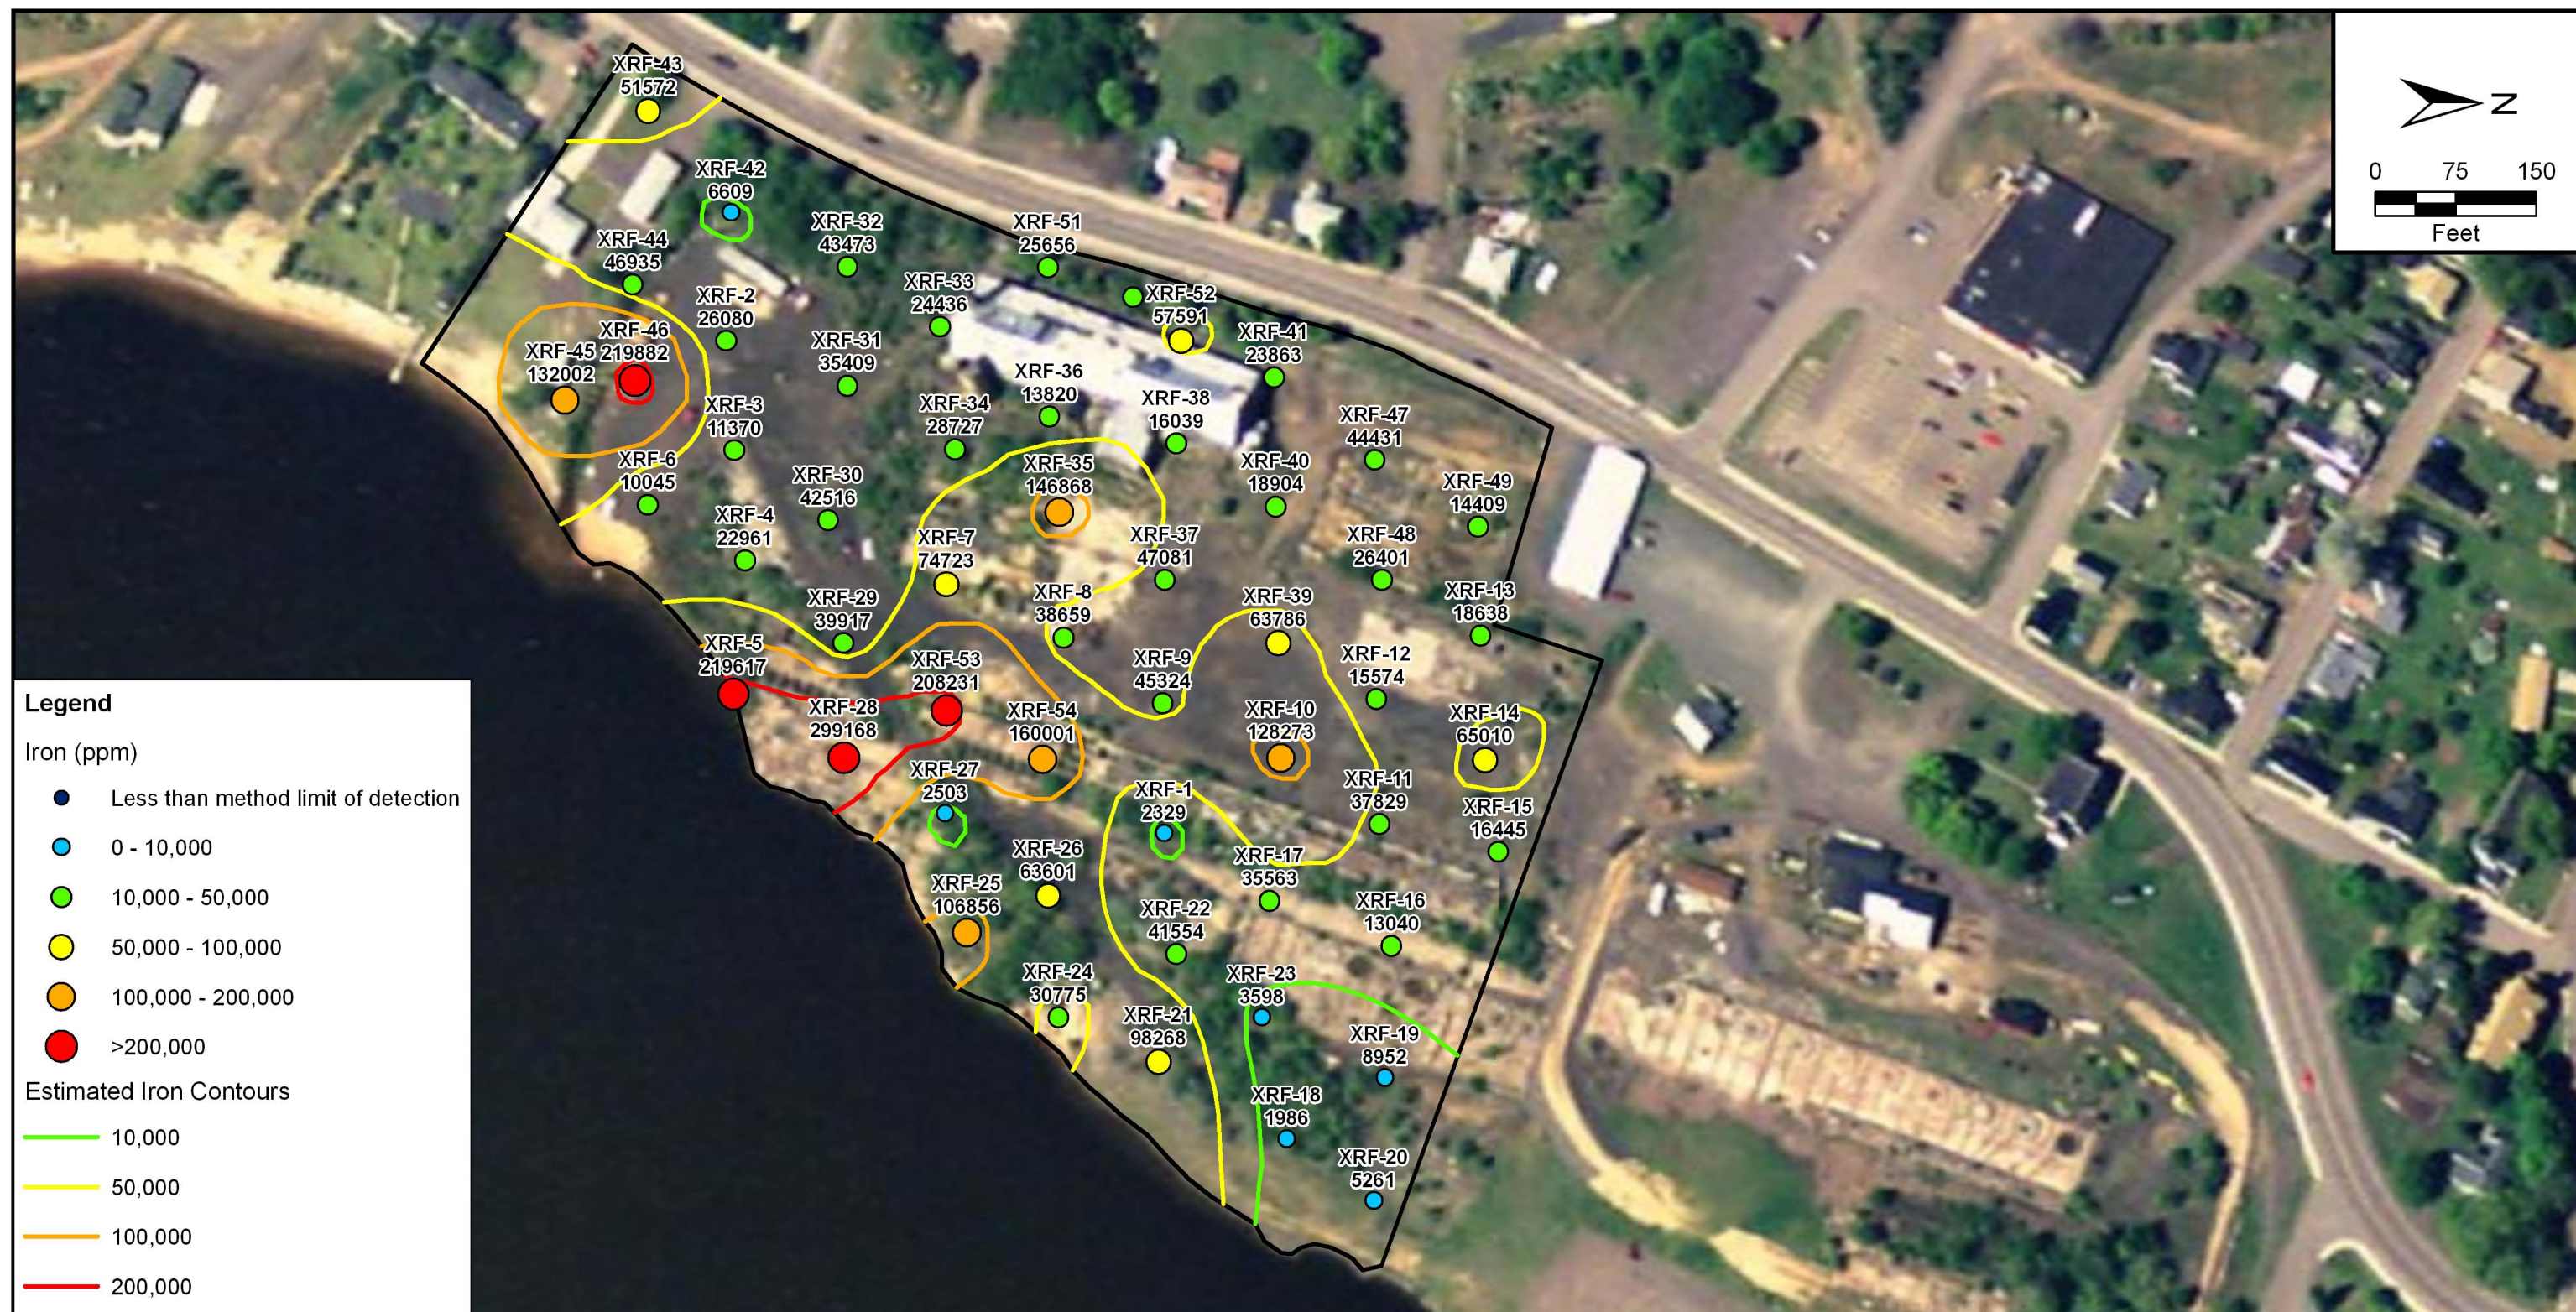
Figure 4-4

XRF SCREENING RESULTS - IRON - JUNE 2010
 C & H POWER PLANT SITE
 LAKE LINDEN, HOUGHTON CO., MICHIGAN
 Created: July 2010

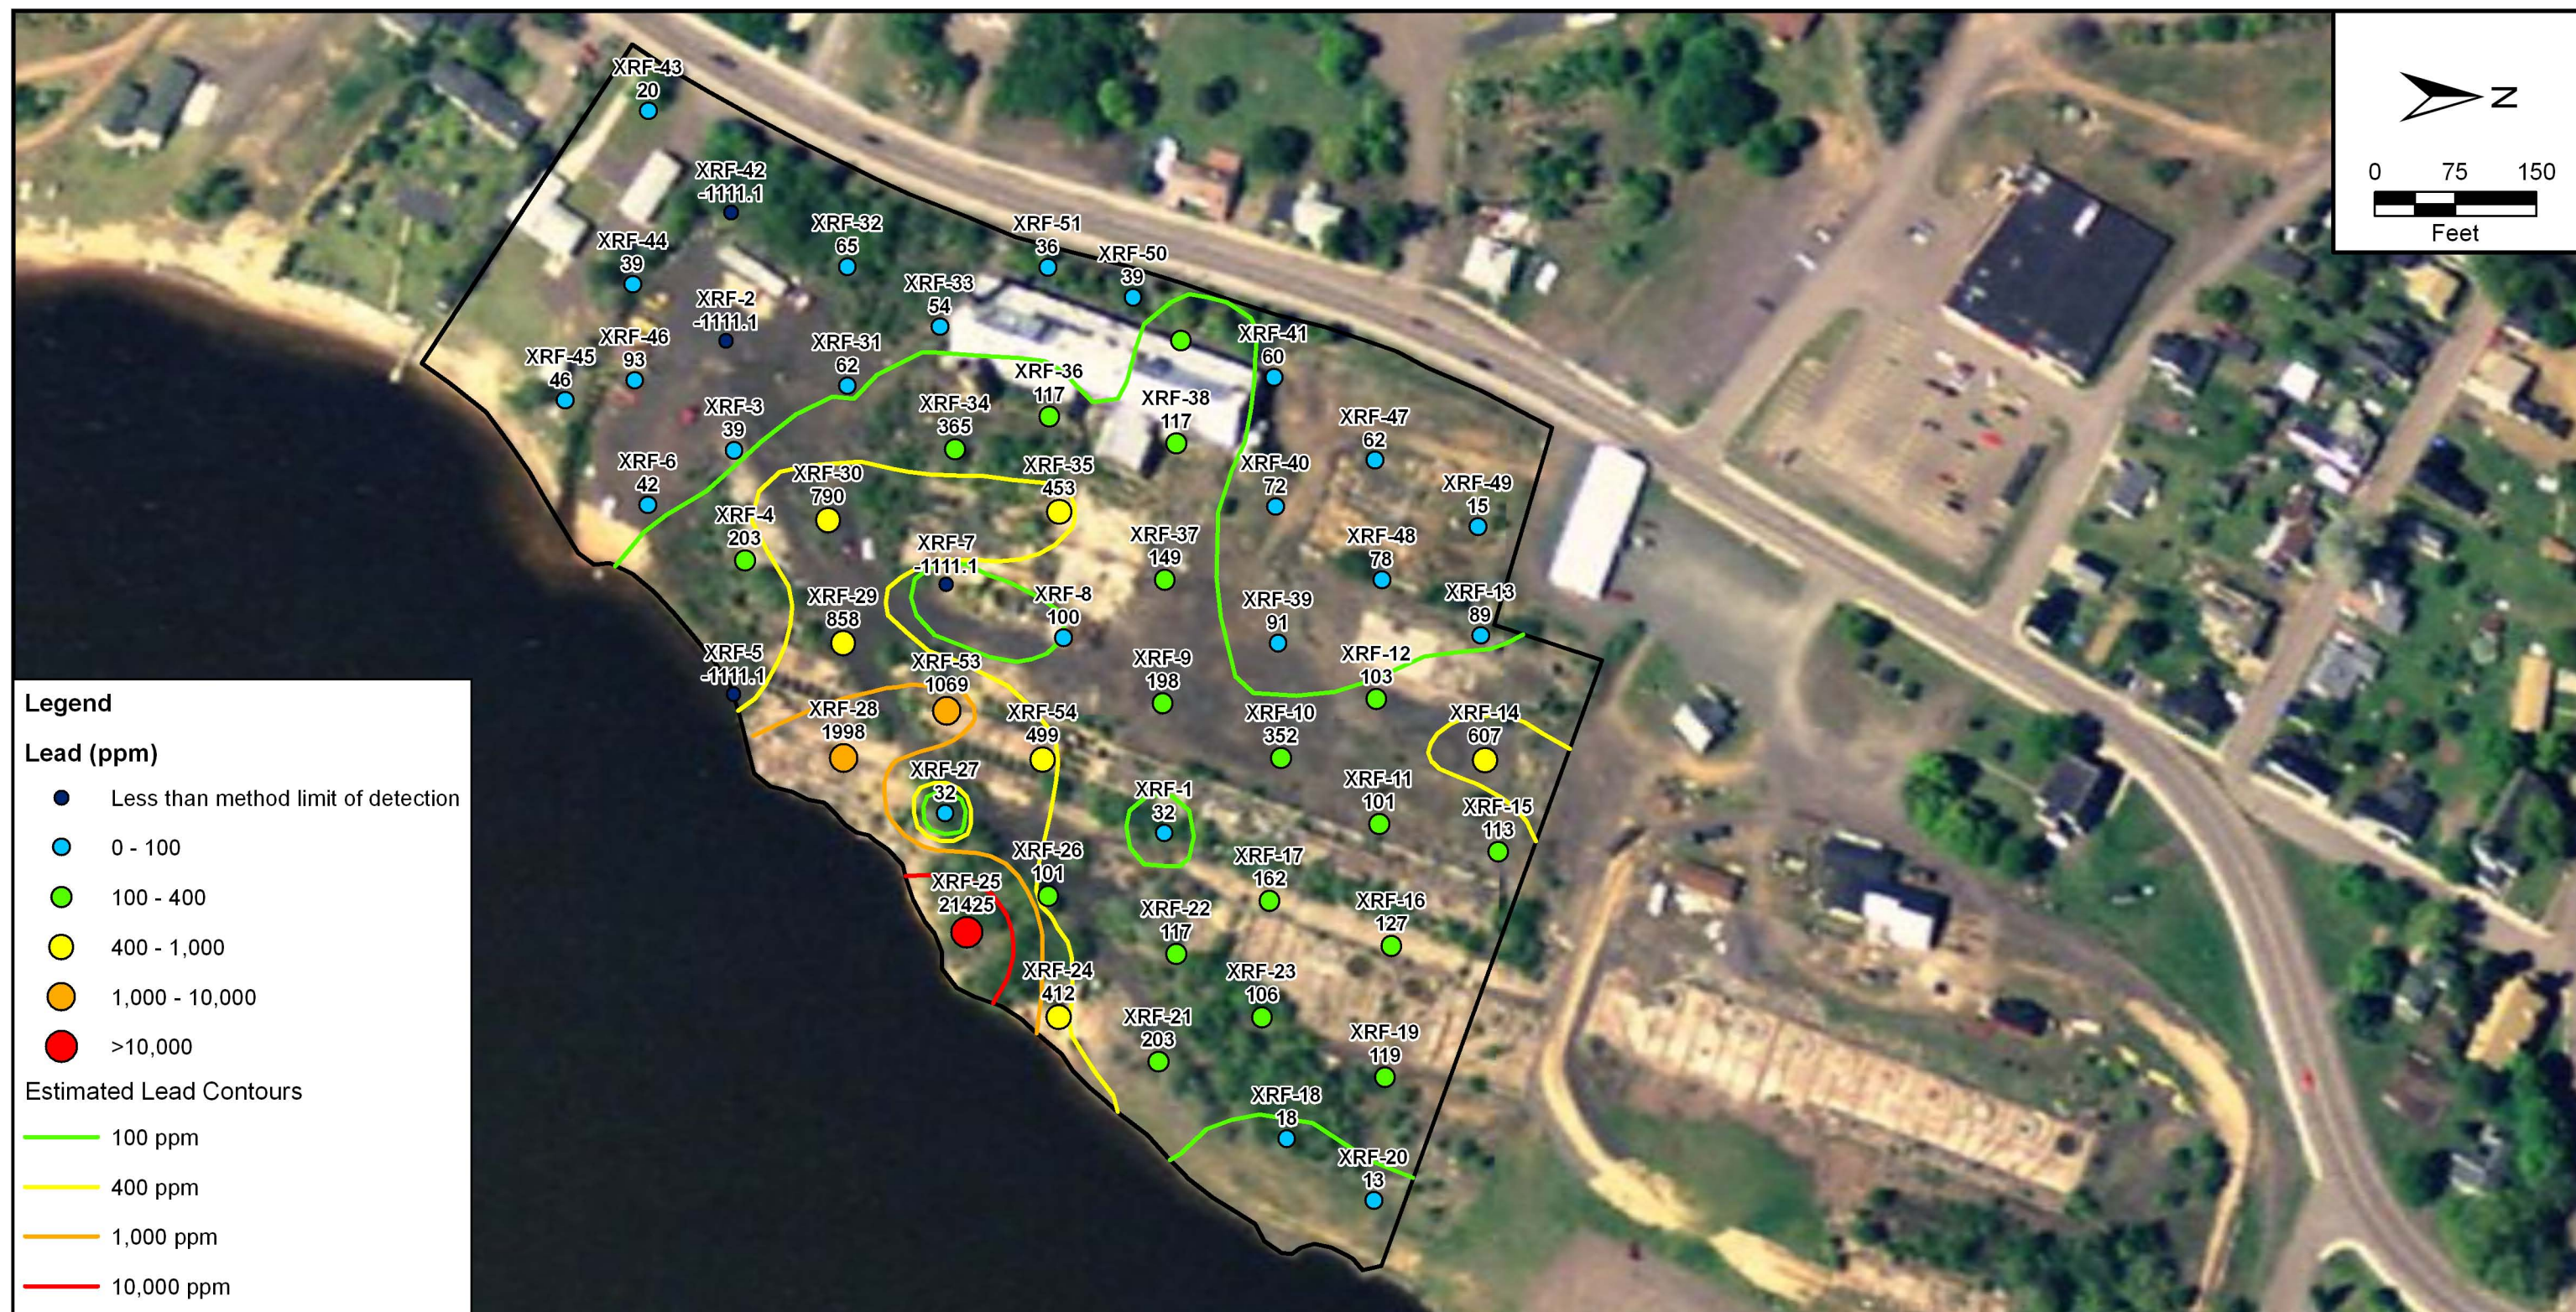
Figure 4-5

Note: -1111.1 = below the method limit of detection. This value is not recorded by the XRF instrument. The lowest detected lead value was 13 ppm.

XRF SCREENING RESULTS - LEAD - JUNE 2010
 C & H POWER PLANT SITE
 LAKE LINDEN, HOUGHTON CO., MICHIGAN
 Created: July 2010

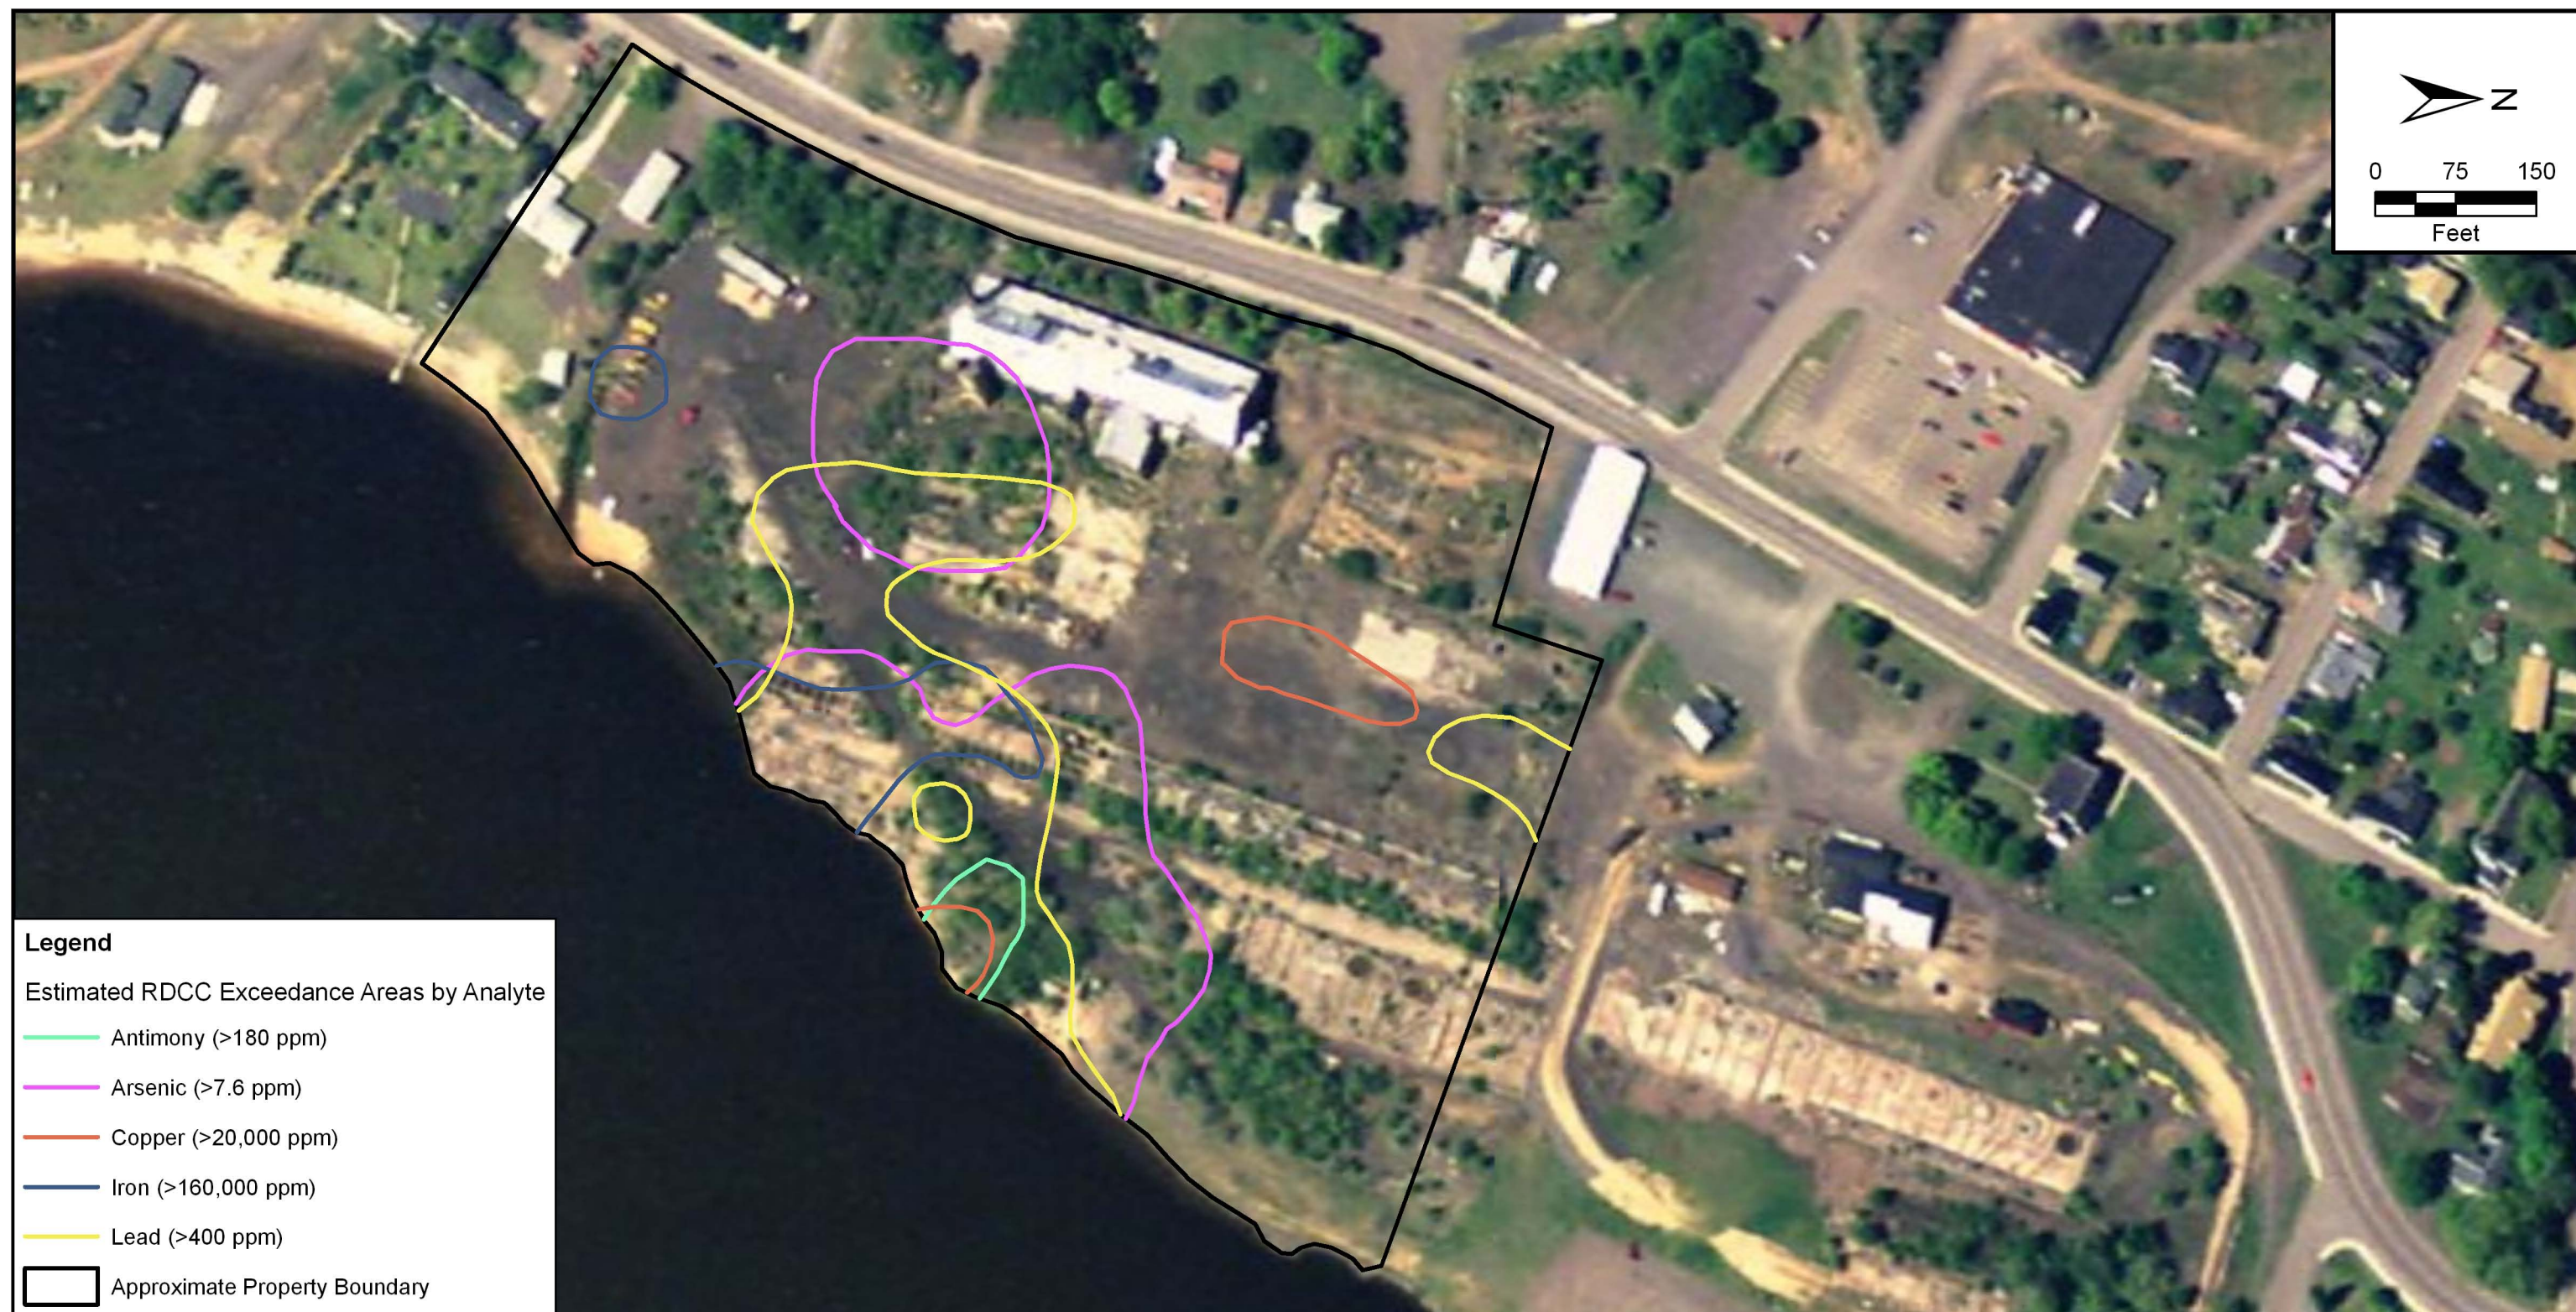
Figure 4-6

Note: RDCC = MDNRE Part 201 Residential Direct Contact Criteria.
 The method limit of detection for arsenic may be higher than 7.6 ppm;
 however, it is not recorded by the XRF.
 The lowest detected arsenic value was 19 ppm.

**COMPOSITE XRF SCREENING RESULTS
 GREATER THAN CRITERIA - JUNE 2010**
 C & H POWER PLANT SITE
 LAKE LINDEN, HOUGHTON CO., MICHIGAN
 Created: July 2010

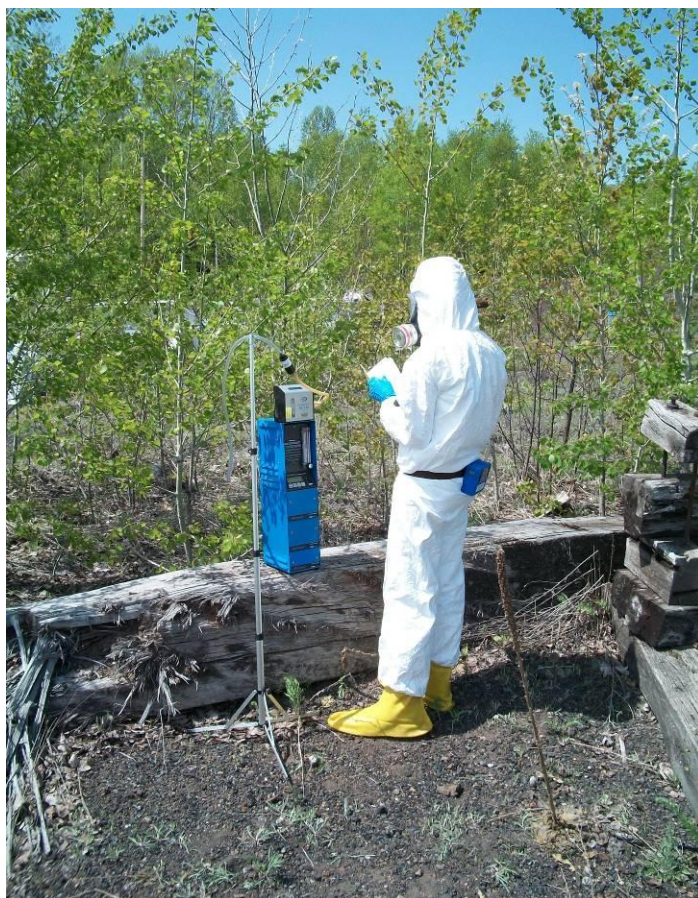
Photo Number: 1

Subject: Monitoring sampler flow rates during exterior air sampling.

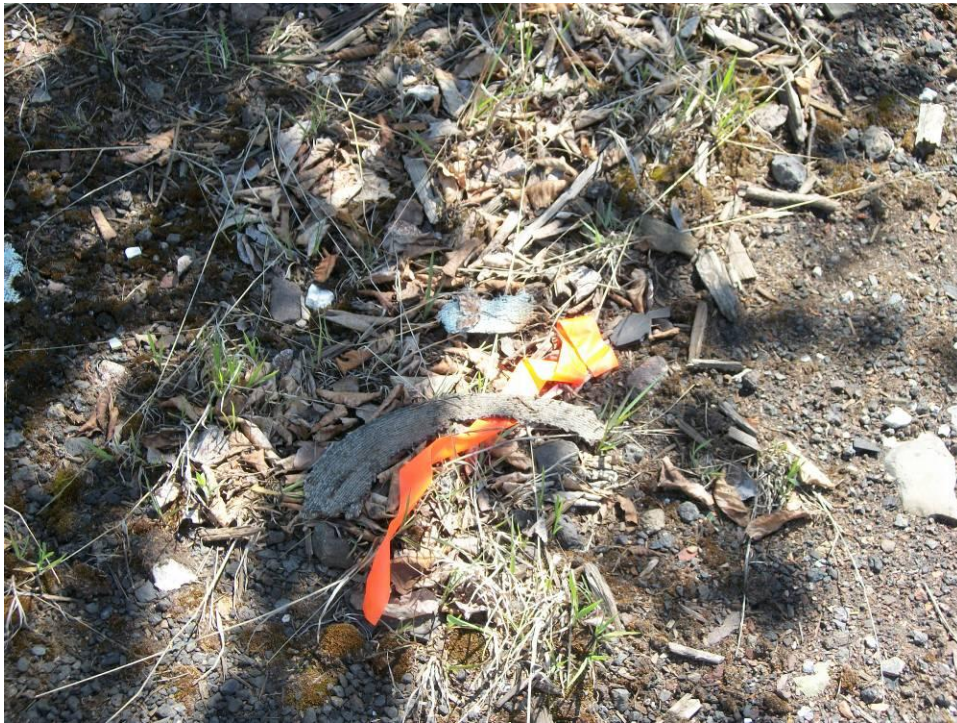
Site: C&H Power Plant
Photo Number: 4
Direction: -
Subject: Gasket (ASB-BLK-43).

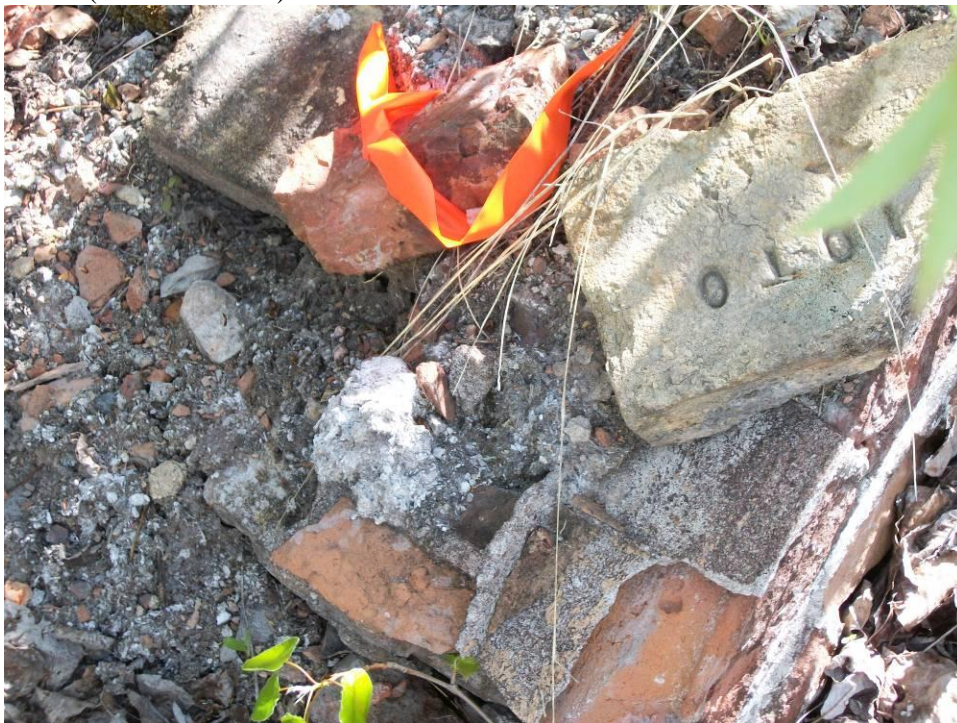
Site: C&H Power Plant
Photo Number: 5
Direction: -
Subject: Fire brick (ASB-BLK-48).
